PRODUCT UPDATE BULLETIN

Product Effected – 3.0L GMPT RH & RL Engines
Date of Bulletin – 04.16.2008
Category – Ignition
Bulletin No. – 042008B

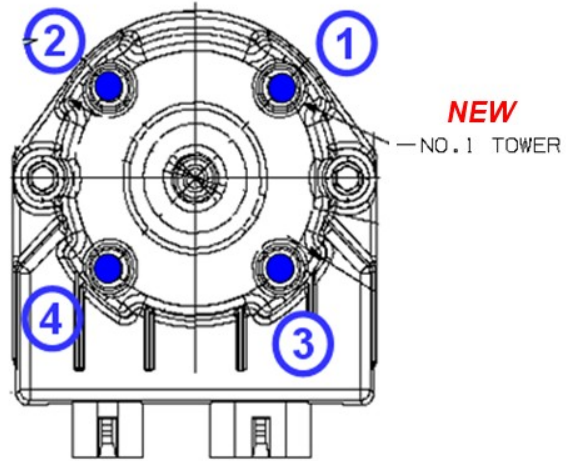
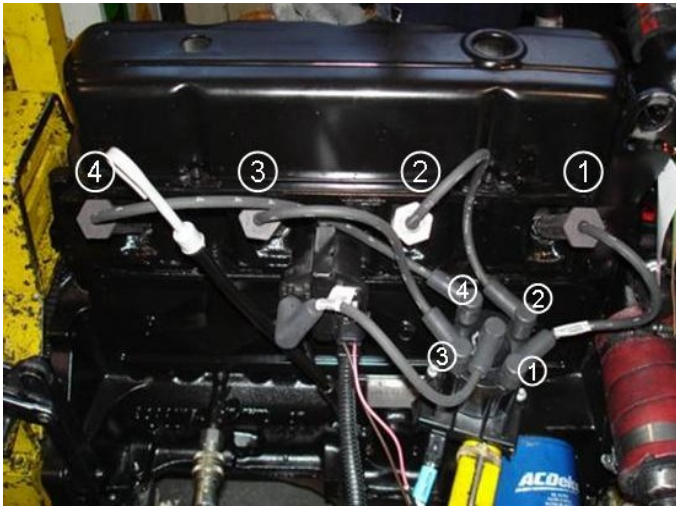
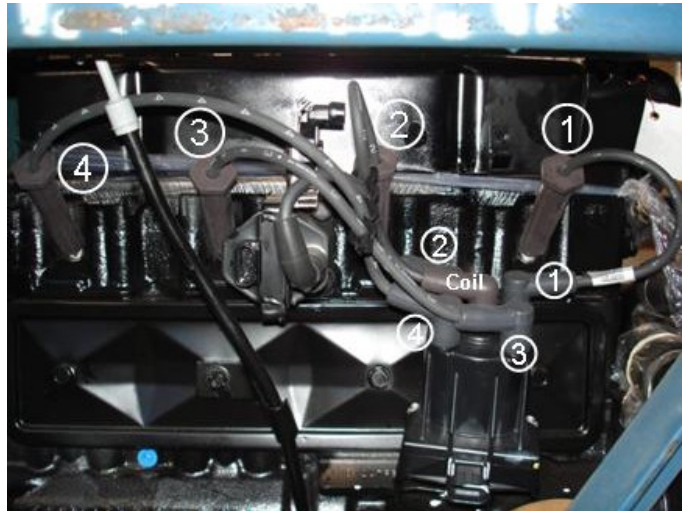
New RL & RH plug wire configuration

Effective on the above build date, the EST distributor tower numbering and spark plug wiring on the RH and RL 3.0L engines will be revised.

To utilize the EST distributor with new tower locations as shown above, the rotor cap is rotated 1 quadrant clockwise (as viewed from above) prior to installation in the engine, and the plugs wires are also installed on the towers one quadrant counterclockwise. The figure below shows the distributor cap and shaft alignment as described above.
