SI14.40-W-0011A	Service Information: Repair solution for pressure reducing valve in pump module of exhaust aftertreatment system	21.10.10
-----------------	--	----------

MODEL 375.3 /4, 930, 932, 933, 934, 940, 942, 943, 944, 950, 952, 953, 954, 957, 958.2 with CODE (MS4) BlueTec 4
MODEL 375.3 /4, 930, 932, 933, 934, 940, 942, 943, 944, 949, 950, 952, 953, 954, 957, 958.2 with CODE (MS5) BlueTec 5
MODEL 375.1, 958.0, 970, 972, 974, 975, 976 with CODE (MS4) BlueTec 4
MODEL 375.1, 958.0, 970, 972, 974, 975, 976 with CODE (MS5) BlueTec 5

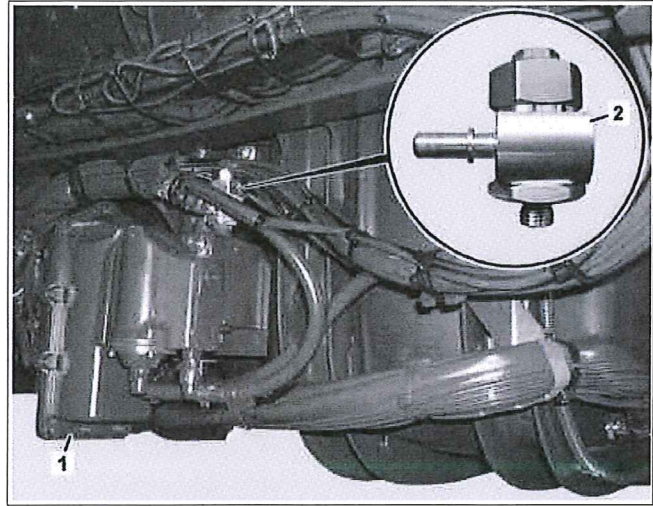
W14.40-1510-11

Shown: pump module A 000 140 04 78 with repair solution, external pneumatic pressure reducing valve

- 1 Pump module
- 2 External pneumatic pressure reducing valve

Mechanical wear can result in pneumatic pressure reducing valves sticking. This leads to malfunctions in the exhaust aftertreatment system.

- **Pump modules with part number: A 000 140 04 78**
In the case of damage an external pneumatic pressure reducing valve (2) can also be installed here, which takes over the function of the internal pressure reducing valve. No additional work must be performed for these pump module variants.
- **Pump modules with part number: A 000 140 05 78**
This pump module does not have the internal pneumatic pressure relief valve fitted in the piston valve type, but rather an internal pneumatic pressure relief valve of the diaphragm valve type. It can be replaced in a case of damage occurring.

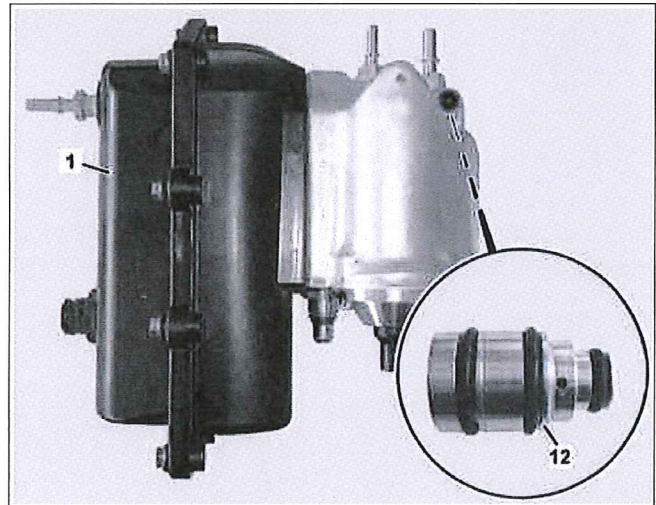
W14.40-1495-11

Shown here pump module A 000 140 05 78 with repair solution, internal pneumatic pressure reducing valve

- 1 Pump module
- 12 Internal pneumatic pressure reducing valve (type of construction: diaphragm valve)
