## PRODUCT SERVICE BULLETIN

No. 200

| <b>COMPONENT AFFECTED:</b> | <b>LOW COOLANT BOARD</b> |

# CONVERSION FROM "OLD" STYLE ISOLATION TRANSFORMER/LOW WATER LEVEL BOARD TO "NEW" STYLE BOARDS ON KASSEC EQUIPPED UNITS

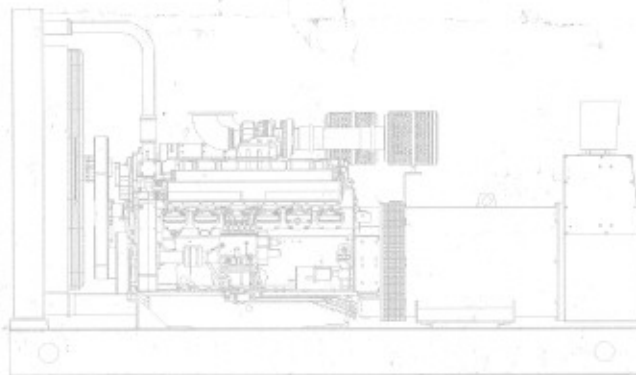
On units shipped from the factory between the affected dates above, there may be a need to change the power supply connection to the low coolant circuit board. This change is required due to a change on the circuit board for the low coolant level only, this circuit change incorporated a latching circuit that will require resetting of the input power to clear the fault after a low coolant shutdown. If this change is not made, when low coolant fault occurs, the fault can only be cleared by removing battery positive from the control panel. Please refer to the attached drawing for wiring instructions.
