TIB-OLY023-00

TECHNICAL INFORMATION BULLETIN

Olympian Gas powered GM8.1 Engines

**SUBJECT:** Approaching Low Oil Pressure warnings and  
Low Oil Pressure shutdowns.

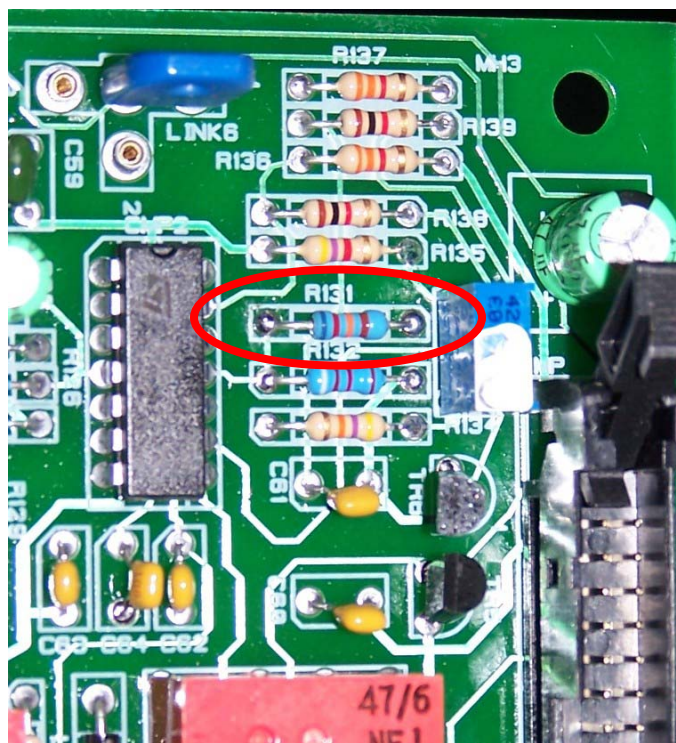
Some of the 4001E expansion boards for the GM product have been fitted with an incorrect resistor that allows nuisance approaching low oil pressure alarms. Resistor R131 should be 62k ohms but may be 39k ohms. The correct (62k ohm) resistor can be identified by the color codes: blue (6), red (2), orange (00) with an additional tolerance color band, or blue (6), red (2), black (0), red (00) with an additional tolerance color band.

Figure 1 – Correct 62k ohm resistor R131

The part number of the correct PCB board is 650-432. However some of the newer boards still have the old part number (650-217) and you will need to verify that the correct resistor has been fitted. See figure 1.
