DETROIT DIESEL

ATS Technician's Guide

NUMBER: 2-ATS-07 **S.M. REF.:** Listed in Table 1 **ENGINE:** ATS **DATE:** April 2007

SUBJECT: UPDATES TO AFTERTREATMENT SYSTEM TROUBLESHOOTING

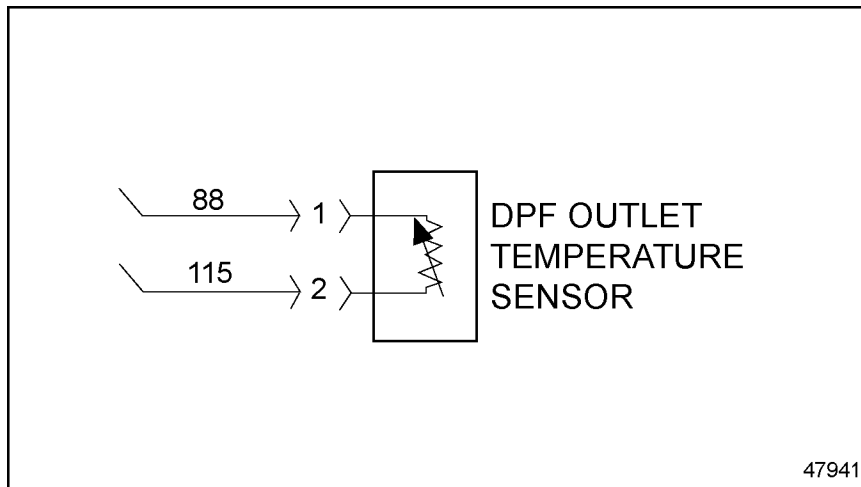
Figure 2 DPF Outlet Temperature Sensor

1. Turn ignition ON (key ON, engine OFF).
2. Monitor DPF Inlet and DPF Outlet Temperature.
 - [a] If the DPF Outlet Temperature 400°C (750°F) is greater than DOC Outlet Temperature, go to step 3.
 - [b] If the DPF Outlet Temperature 400°C (750°F) is less than DOC Outlet Temperature, go to step 5.
3. Turn ignition OFF.
4. Disconnect DPF Outlet Temperature Sensor and inspect connector for damaged, bent, spread, or corroded pins. If the temperature sensor connector is OK, the connections upstream to the MCM (ATD harness 10-pin connector pin 7, 31-pin VIH connector pin 19, and the 120-pin MCM connector pin 115) must also be checked, see Figure 2.

- [a] If found, repair connector as necessary. Verify repairs.
 - [b] If OK, replace DPF Outlet Temperature Sensor. Verify repairs.
5. Remove Aftertreatment Device.

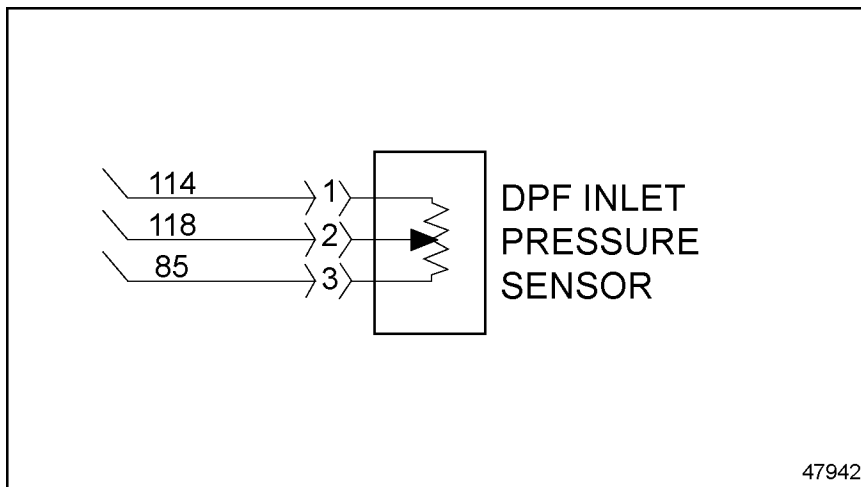
Figure 3 DPF Inlet Pressure Sensor

1. Turn ignition ON (key ON, engine OFF)
2. Check for multiple codes.
 - [a] If 3609/3 and 3610/3, are present, go to step 3.
 - [b] If only 3609/3 is present, go to step 5.
3. Disconnect the DPF Inlet Pressure Sensor.
4. Measure the voltage between pin 1 of the DPF Inlet Pressure Sensor and ground (battery ground lug by starter).
 - [a] If the voltage is present, repair the short to power between pin 114 of the 120-pin MCM connector and the DPF Inlet and DPF Outlet pressure sensors. Verify repairs.
 - [b] If no voltage is present on pin 1 of the DPF Inlet Pressure Sensor, repair the open between pin 114 of the 120-pin MCM connector and DPF Inlet, pin 1 and DPF Outlet, pin 1 pressure sensors. Verify repairs.
5. Disconnect DPF Inlet Pressure Sensor connector. See Figure 3.

-
6. Turn the ignition switch to the OFF position.
 7. Disconnect the 120-pin MCM connector.
 8. Measure the resistance across pins 2 and 3 of the DPF Inlet Pressure Sensor connector.
 - [a] If the resistance is less than 5 Ω , repair the short between the 120-pin MCM connector wires 85 and 118. Verify repairs.
 - [b] If the resistance is greater than 5 Ω , repair short to power on circuit between the 120-pin MCM connector pin 118 and the DPF Inlet Pressure Sensor connector pin 2. Verify repairs.

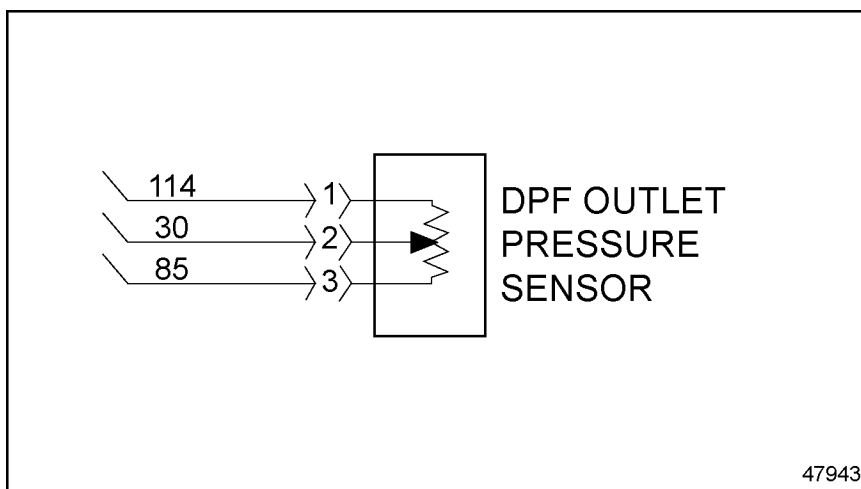
Figure 4 DPF Outlet Pressure Sensor

1. Turn ignition ON (key ON, engine OFF).
2. Check for multiple codes.
 - [a] If 3610/3 and 3609/3 are present, go to step 3.
 - [b] If only 3610/3 is present, go to step 5.
3. Disconnect the DPF Outlet Pressure Sensor.
4. Measure the voltage between pin 1 of the DPF Outlet Pressure Sensor and ground (battery ground lug by starter).
 - [a] If the voltage is greater than 2.75 volts, repair the short to power between pin 114 of the 120-pin MCM connector and the DPF Inlet and DPF Outlet pressure sensors. Verify repairs.
 - [b] If no voltage is present on pin 1 of the DPF Outlet Pressure Sensor, repair the open between pin 114 of the 120-pin MCM connector and DPF Inlet and DPF Outlet pressure sensors. Verify repairs.
5. Disconnect DPF Outlet Pressure Sensor connector. See Figure 4.

6. Turn the ignition switch to the OFF position.
7. Disconnect the 120-pin MCM connector.
8. Measure the resistance across pins 2 and 3 of the DPF Outlet Pressure Sensor connector.
 - [a] If the resistance is less than 5 Ω , repair the short between the 120-pin MCM connector wires 30 and 85. Verify repairs.
 - [b] If the resistance is greater than 5 Ω , repair short to power on circuit between the 120-pin MCM connector pin 30 and the DPF Outlet Pressure Sensor connector pin 2. Verify repairs.
