DDEC® VI Troubleshooting

NUMBER: 08 DDEC VI-27 S.M. REF.: 116 ENGINE: DD15 DATE: May 2008

SUBJECT: SPN 3598

PUBLICATION: DDC-SVC-MAN-0029

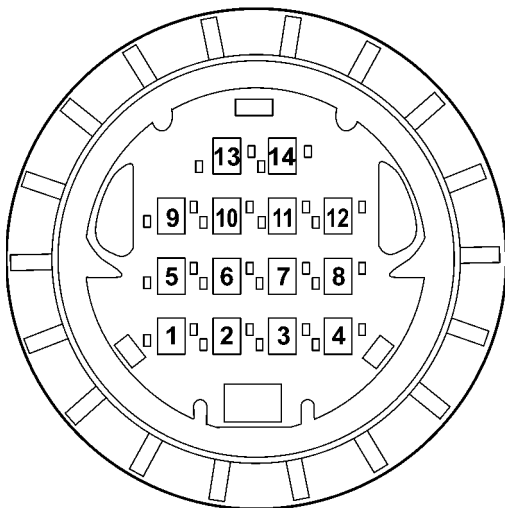
ENGINE HARNESS SIDE

3. Measure the resistance between pin 14 on the engine side of the Valve Cover Injector Harness connector and ground.
 - [a] If the resistance is less than 5 Ω , repair the short to ground between the Rear Valve Cover Injector Harness and the medium (rear) engine brake solenoid.
