DDEC® VI Troubleshooting

NUMBER: 08 DDEC VI-45 S.M. REF.: 88 ENGINE: DD15 DATE: September 2008

SUBJECT: NEW SPN 157

PUBLICATION: DDC-SVC-MAN-0029

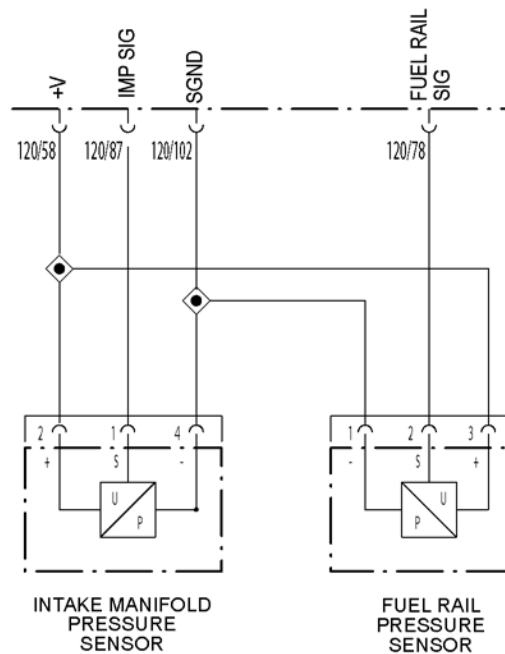
d150007a

SPN 157/FMI 2

This diagnostic condition is typically an erratic Fuel Rail Pressure Sensor signal.

1. Disconnect the Fuel Rail Pressure Sensor.
2. Inspect the Fuel Rail Pressure Sensor harness connector for loose, bent, spread or corroded pins.
 - [a] If pin damage is found, repair as necessary. Verify repairs.

- [b] If no connector damage is found, go to the next step.
3. Disconnect the MCM 120-pin connector.
4. Inspect pins 58, 78, and 102 for bent, spread or corroded pins.

- [a] If pin damage is found, repair as necessary. Verify repairs.
 - [b] If no connector damage is found, go to the next step.
5. Connect DDDL 7.X.
6. Turn the ignition ON (key ON, engine OFF).

7. Under the Actions” drop down menu, select “PLV Change.” On the PLV Change screen select “Read Accumulator.”
 - [a] If the PLV counter is greater than 50, the PLV must be replaced. After PLV replacement, reset the PLV accumulator value via the “Reset Accumulator” button.

- [b] If the PLV counter is less than 50, troubleshooting is complete.
