NO.: 04 TS – 30 (REVISED)
July 22, 2004

TO: All Distributors/Dealers and Their Branches
ATTN.: Service Managers
FROM: David J. Mester
SUBJECT: **MBE 900 - Allison Transmission Shift Delay**

(This letter replaces the 04 TS – 30 version released June 10, 2004.)

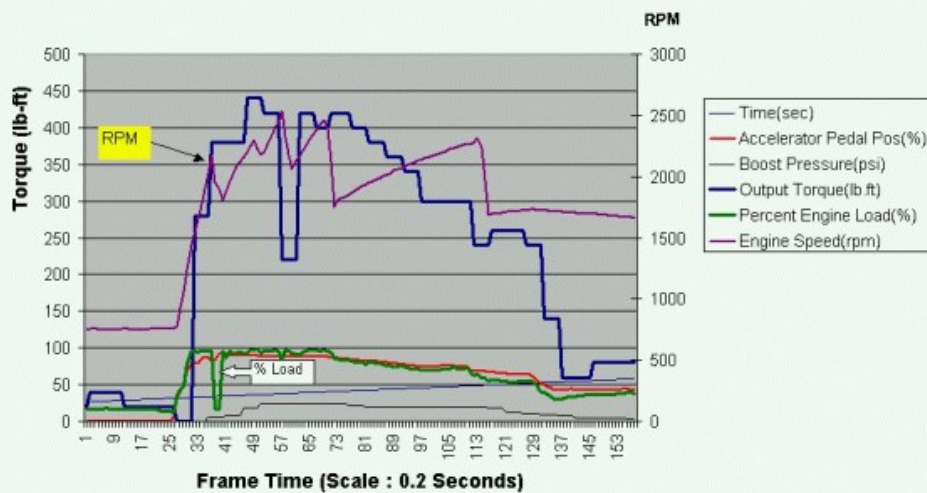
MBE Engine Torque Dropout

The symptoms experienced by the driver are an engine hesitation and loss of power during the one – two up-shift, (Figure below). In addition, the transmission up-shift point going from two to three is influenced, but lacks the severity of power loss as recorded between the one - two up-shift.

The snapshot data in the above figure was extracted from a Thomas Bus with the 3DL electronic tool. It identifies a momentary loss of requested engine torque, followed by the significant loss of engine speed during the one - two up-shift for a period of approximately 0.5 seconds.

DDC Electronic Engineers discovered a critical calculation was omitted after the release of VCU software version 14.19, which caused the requested torque to drop approximately to zero therefore creating the up-shift concern.

The field concern can be resolved by using either the Mini-Diag or the DRS station and changing the following Vehicle Control Unit (VCU) parameter group:

1. Group 23 \ Limiter II
2. Click: Parameter # 35 \ Acceleration Limiter During Shift
3. Change setting from 1 to zero

This parameter setting is used with the Allison 4000 Heavy Duty Transmission equipped with the acceleration limiter. The above procedure will deactivate the feature and allow the Allison 1000, 2000, and 3000 Transmission to shift properly without harm to the MBE 900 Engine or Allison Transmission. The software calculation has been corrected by DDC Electronic Engineers and will be released to VCU software version 14.20.
