No.: 04 TS – 57 (Rev.)
November 29, 2004

TO: All Distributors, Dealers, and their Branches – U.S. & Canada
ATTN.: General Manager, Service Manager
FROM: Technical Service
SUBJECT: **MBE 900 Model Year 2004 EGR Overheat Condition**

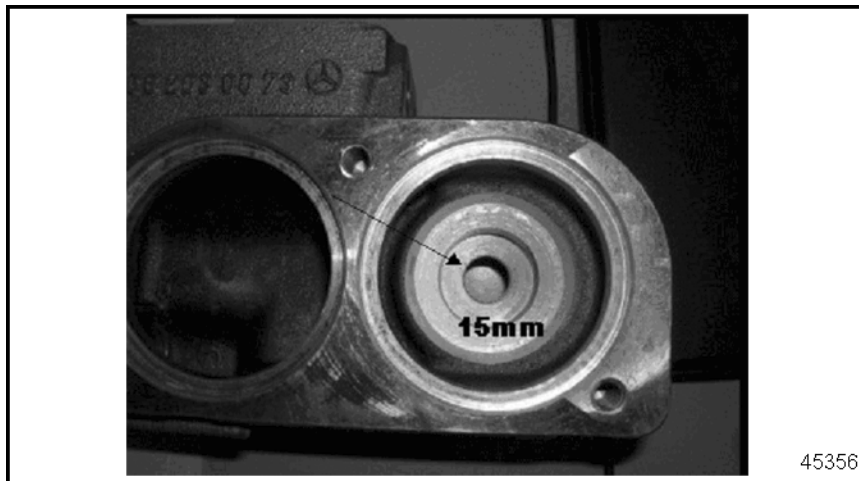
Figure 1 Restrictor Hole of Lower Thermostat Housing

Thermostat failures were found as a result of investigating the high engine coolant temperature. The primary cause for the failures has been attributed to the lower thermostat housing being manufactured to the non-EGR specification with a 15 mm restrictor hole instead of the 30 mm restrictor hole required for EGR engines. See Figure 1.

The 2004 model year EGR units incorporate a high-output water pump that requires the lower thermostat housing to have a 30 mm bore. The increased dimension from 15 mm to 30 mm allows the engine to maintain a constant coolant temperature and reduces stress to the associated cooling system components.

The corrective action plan will be to replace the lower thermostat housing.
