No.: 05 TS – 01
January 6, 2005

SUBJECT: **Charge Air Cooler Leaks**

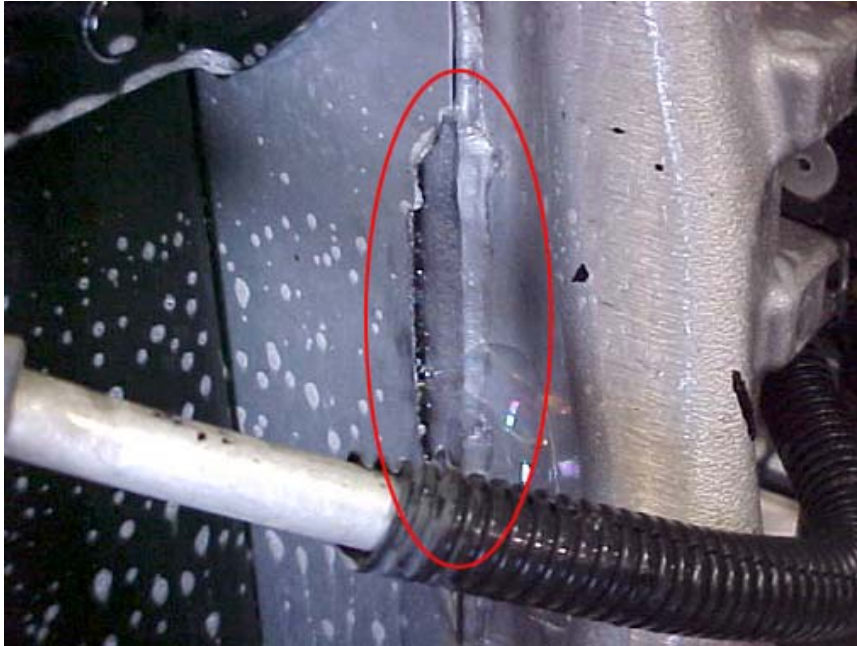
Leaks in the air-to-air cooling system result in a loss of boost pressure than can cause low power, excessive smoke, high exhaust temperatures, and elevated oil soot levels. Recently, several extreme cases have been noted where high exhaust temperatures have warped the turbocharger mounting flange (requiring replacement of the turbocharger), and high soot levels caused serious lubrication oil degradation and subsequent damage to the engine.

Figure 1 **Cracked Charge Air Cooler Housing**

The CAC system *MUST* be routinely inspected for broken hoses, loose clamps and dirty, obstructed, or failed coolers. For on-highway vehicles, the *Series 60 Operator's Guide* (6SE484) states that the CAC and ductwork must be inspected every 15,000 miles or 6 months, whichever comes first. Damage to any of these components requires immediate repairs. Large CAC leaks can possibly be found visually, while small leaks will have to be found using a pressure loss leak test. The *Series 60 Service Manual* (6SE483) contains information on how to pressurize the CAC system to check for leaks. SIB #12-60-03 published June 17, 2003, also contains this information. See Figures 1 and 2 for examples of leaking Series 60 charge air coolers.

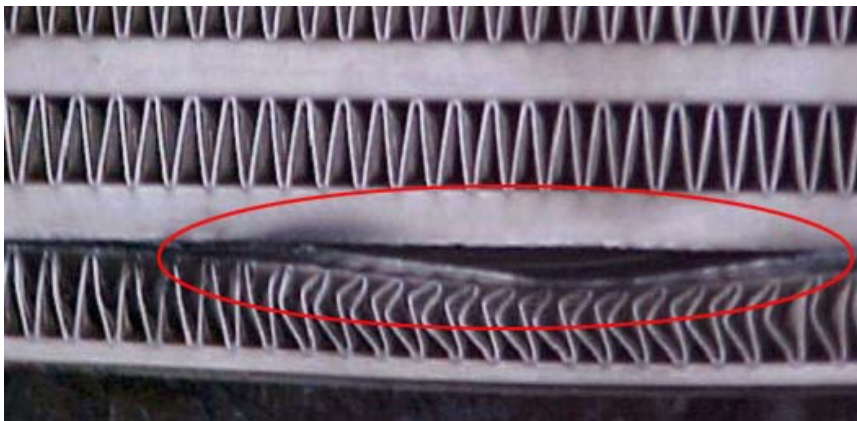
Figure 2 **Failed Charge Air Cooler Core**
