**No.: 05 TS – 05Rev**  
February 9, 2006

SUBJECT: **MBE900 Frozen Breather Tubes**

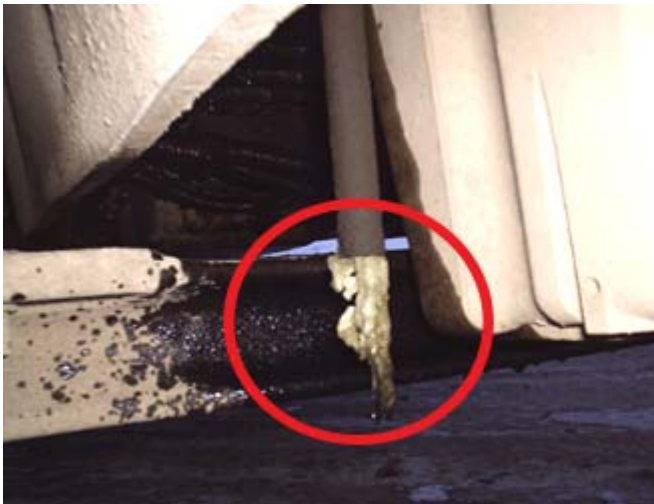
- The end of the breather tube can potentially freeze on MBE900 engines under extremely cold operating conditions.
- The breather tube is currently routed along the right side, near the front of the engine and down past the oil pan rail close to the bottom of the oil pan (see Figure 1).

Figure 1 - Frozen Breather Tube

- Replace the breather tube with the improved design.
- The new design incorporates a larger diameter at the end of the tube, slightly shorter length, and a 45-degree angle cut at the end of the tube (see Figure 2).
- These changes will help keep the tube warmer and reduce the chance of snow and slush from the roadway coming in contact with the tube and subsequently freezing.
- The new tube became effective with engine serial number 90291900526389 built on October 19, 2005.

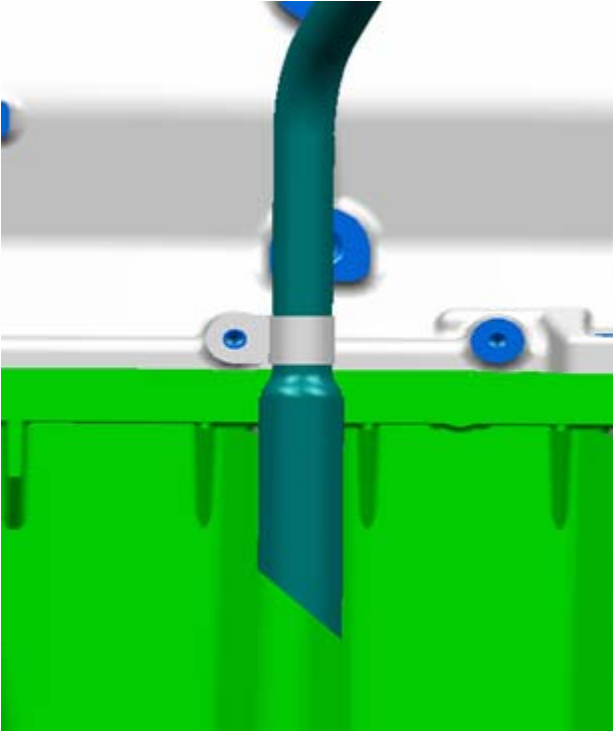
Figure 2 - New Breather Tube

The improved breather tube is P/N: 9060181712.
