No.: 05 TS – 40Rev2
November 22, 2006

SUBJECT: **MBE 4000 EGR Temperature Sensor**

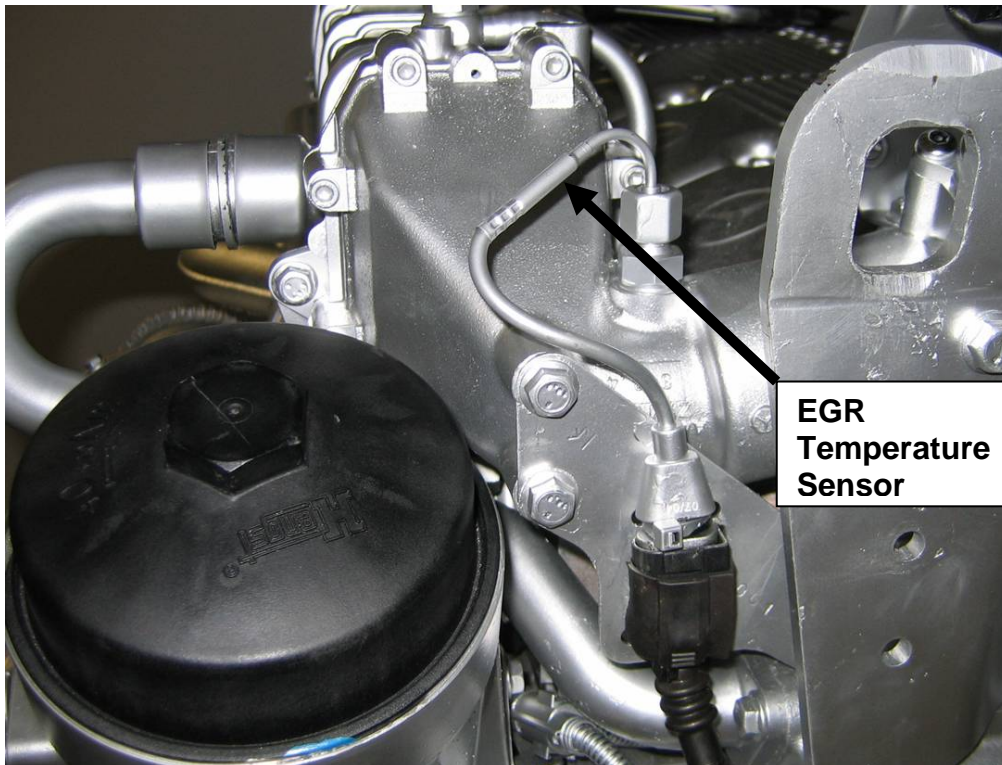
Figure 1 EGR Temperature Sensor

Broken tips on the EGR temperature sensor

EGR Temperature Sensor failure resulting in one or more of the codes below:

- EGR System-Temperature Above Normal (SID 146, FMI 0)
- EGR System-Temperature Below Normal (SID 146, FMI 1)
- EGR System-Bad Component (SID 146, FMI 12)

The broken tip can cause downstream internal damage to the engine. See (Figure 1).

If the EGR Temperature Sensor fails, do not install another sensor. Remove the sensor, install a plug in the pipe and in the electrical harness, and re-flash the PLD with a new fuel map to turn off the sensor.
