**No.: 05 TS - 45**  
October 24, 2005

SUBJECT: **MBE4000 Fuel Line Inspections**

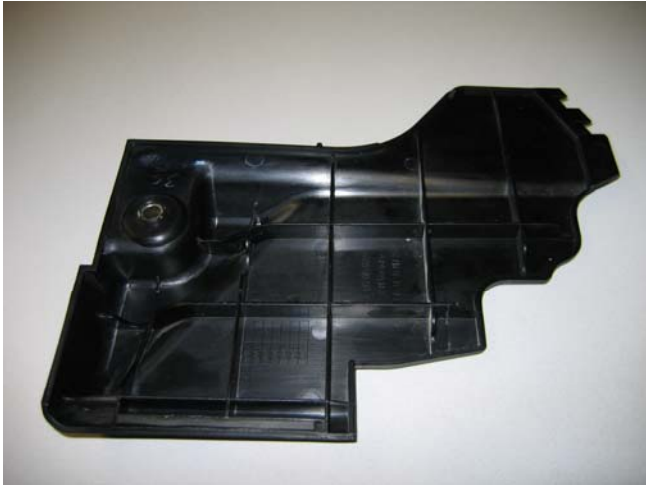
**Figure 1 Rear Engine Cover (Stock)**

- Fuel injector spill line rubbing on rear engine cover on units prior to engine S/N 460805219.
- Main fuel return line leakage on left side of engine on units prior to engine S/N 460801977.

- Fuel line interference with rear engine cover.
- Improper installation of tie straps.

1. Remove rear engine cover p/n 4600100290. (See Figure 1)
