No.: 05 TS – 47Rev
May 19, 2006

SUBJECT: **MBE 900 EGR Temperature Sensor**

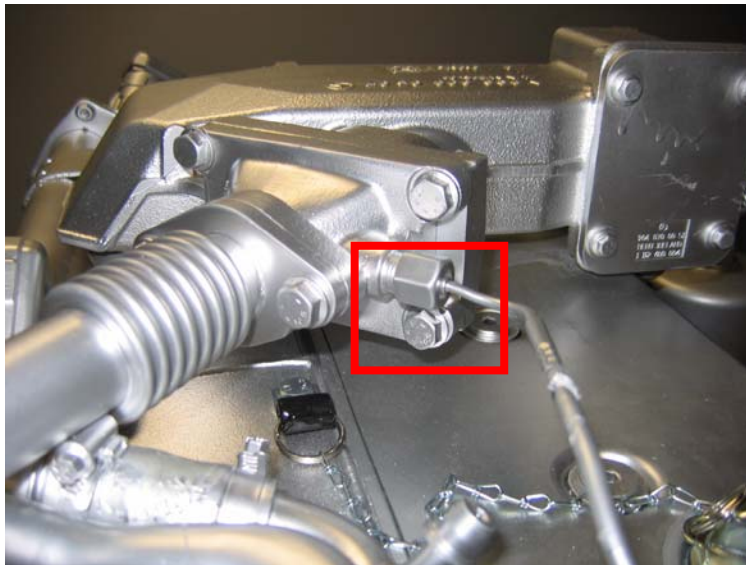
Figure 1 EGR Temperature Sensor

EGR Temperature Sensor failure resulting in one or more of the codes below:

- EGR System-Temperature Above Normal (SID 146, FMI 0)
- EGR System-Temperature Below Normal (SID 146, FMI 1)
- EGR System-Bad Component (SID 146, FMI 12)

Faulty EGR Temperature Sensor.

Do NOT replace the sensor. Reflash the PLD to turn off the sensor (refer to figure 2).

1. Confirm the sensor is at fault by following the troubleshooting steps for SID 146 in the *MBE900/4000 EGR Technician's Guide (7SE940)*.
2. If the sensor is at fault, do NOT replace the sensor. Leave the electrical harness connected to the sensor.
3. Reflash the PLD to update the fuel map which will turn off the sensor (Refer to Figure 2).
