No.: 06 TS - 09  
April 4, 2006

SUBJECT: **Troubleshoot Code 57/04 PWM Driver #1 Shorted to Ground**

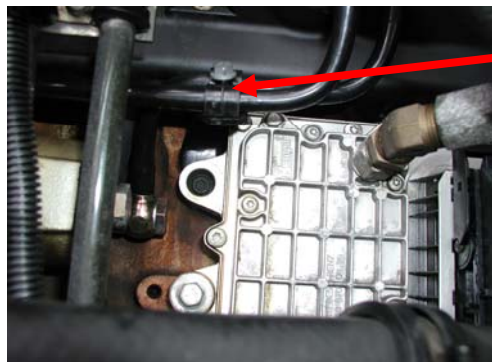
1. PLD case – is it grounded?
  - a) Check the PLD:
    - o Ignition key is off
    - o Both the 16 and the 55 pin connectors are attached to the PLD
    - o Using a DVOM (digital volt ohm meter) check the resistance between the PLD case (PLD installed on the engine) and the engine block and then check the resistance between the PLD case and the negative terminal of the battery
    - o Resistance value in both locations should be approximately 1k ohm.
  - b) If the resistance reading is low (e.g. 0.2 to 0.4 ohms) this indicates that the PLD is grounded. Possible causes are:
    - o Defective PLD
    - o Improper PLD mounting
    - o Steel braided fuel supply line (MBE 4000 only – incorporates fuel cooler on the PLD)
    - o Any other metal brackets or fasteners that come in contact with the PLD

This only applies to EPA 98 4000's in Sterling and Western Star trucks.

Figure 1 Bolt and Bracket Securing the Fuel Lines
