DETROIT DIESEL

DDEC[®] VI Troubleshooting

NUMBER: 07 DDEC VI-16 S.M. REF.: 74 ENGINE: MBE 4000 DATE: September 2007

SUBJECT: SPN 723

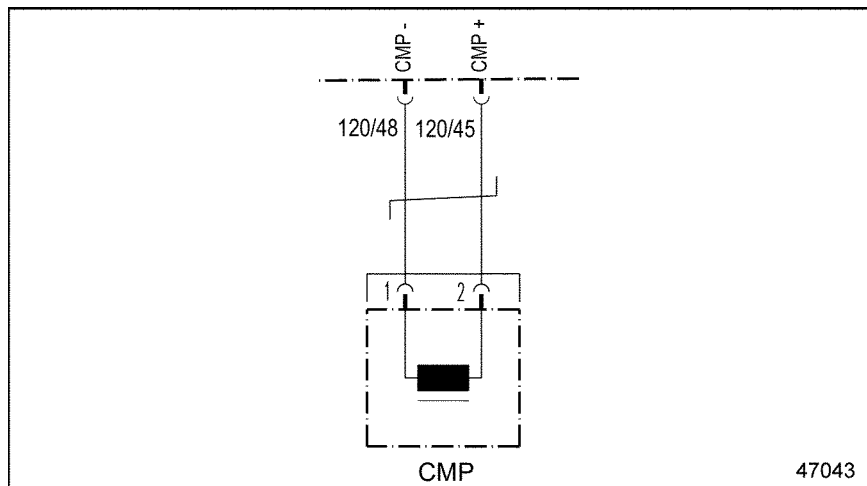
Figure 1 Camshaft Position Sensor

There is a pin number change for SPN 723/FMI 3 and SPN 723/FMI 4. In both procedures, pin 44 has changed to pin 48.

The diagnostic condition is typically an open circuit.

1. Disconnect CMP Sensor
2. Measure the resistance across pins 1 and 2 of the CMP Sensor. See Figure 1.
 - [a] If the resistance is between 100 Ω and 140 Ω , go to step 3.
 - [b] If the resistance is greater than 140 Ω or less than 100 Ω , replace the CMP Sensor. Verify repairs..
3. Disconnect the 120-pin MCM connector.

4. Measure the resistance across pins 1 and 2 of the CMP harness connector.
 - [a] If the resistance is less than 5 Ω , repair short between pins 1 and 2 of the CMP harness connector and the pins 48 and 45 of the MCM 120 pin connector. Verify repairs.

- [b] If the resistance is greater than 5 Ω , go to step 5.
5. Measure the resistance between pin 1 of the CMP harness connector and pin 48 of the MCM 120 pin connector

- [a] If the resistance is greater than 5 Ω , repair open between pin 1 of the CMP harness connector and pin 48 of the MCM 120 pin connector. Verify repairs.

- [b] If the resistance is less than 5 Ω , go to step 6.
6. Measure the resistance between pin 2 of the CMP harness connector and pin 45 of the MCM 120 pin connector.

- [a] If the resistance is greater than 5 ohms, repair open between pin 2 of the CMP harness connector and pin 45 of the MCM 120-pin connector. Verify repairs.

- [b] If the resistance is less than 5 Ω , review steps 2 through 6. If the results are the same, contact the Detroit Diesel Customer Support Center (313-592-5800).

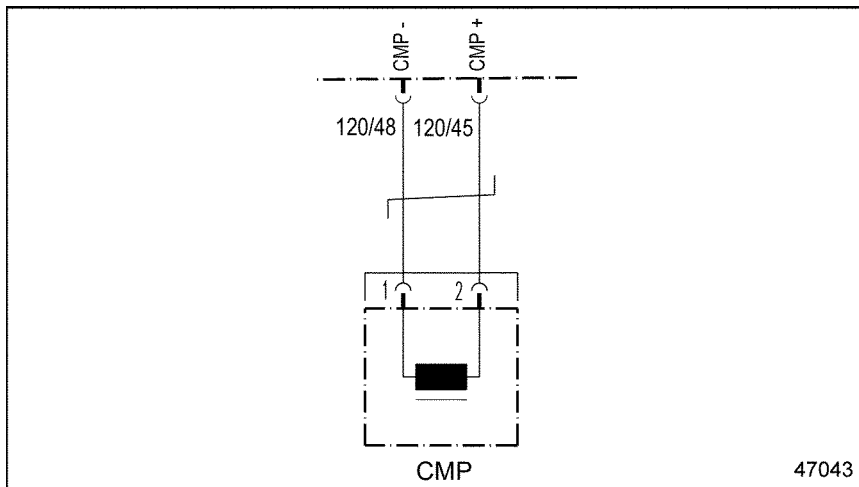
Figure 2 MCM — Camshaft Position Sensor Schematic

A typical diagnosis is a short to ground.

1. Disconnect the CMP Sensor.
2. Measure the resistance between pin 1 of the CMP Sensor and ground. See Figure 2.

- [a] If the resistance is greater than 5 Ω , go to step 3.
 - [b] If the resistance is less than 5 Ω , replace the CMP Sensor. Verify repairs.
3. Measure the resistance between pin 2 of the CMP Sensor and ground.
 - [a] If the resistance is greater than 5 Ω , go to step 4.
 - [b] If the resistance is less than 5 Ω , replace the CMP Sensor. Verify repairs.
 4. Disconnect 120-pin MCM connector.
 5. Measure the resistance across pins 1 and 2 of the CMP harness connector.
 - [a] If the resistance is greater than 5 Ω , go to step 6.
 - [b] If the resistance is less than 5 Ω , repair the short between pins 1 and 2 of the CMP harness connector and pins 48 and 45 of the 120-pin MCM connector. Verify repairs.

6. Measure the resistance between pin 1 of the CMP harness connector and ground.
 - [a] If the resistance is greater than 5 Ω , go to step 7.
 - [b] If the resistance is less than 5 Ω , repair the short to ground between pin 1 of the CMP harness connector and pin 48 of the 120-pin MCM connector. Verify repairs.
7. Measure the resistance between pin 2 of the CMP harness connector and pin 45 of the 120-pin MCM connector.
 - [a] If the resistance is greater than 5 Ω , review steps 2 through 7. If the results are the same, contact Detroit Diesel Customer Support Center (313-592-5800).
 - [b] If the resistance is less than 5 Ω , repair the short to ground between pin 2 of the CMP harness connector and pin 45 of the 120-pin MCM connector. Verify repairs.
