DDEC® VI Troubleshooting

NUMBER: 07 DDEC VI-42 S.M. REF.: 109 ENGINE: EPA07 MBE 4000 DATE: December 2007

SUBJECT: SPN 3563

PUBLICATION: 6SE568

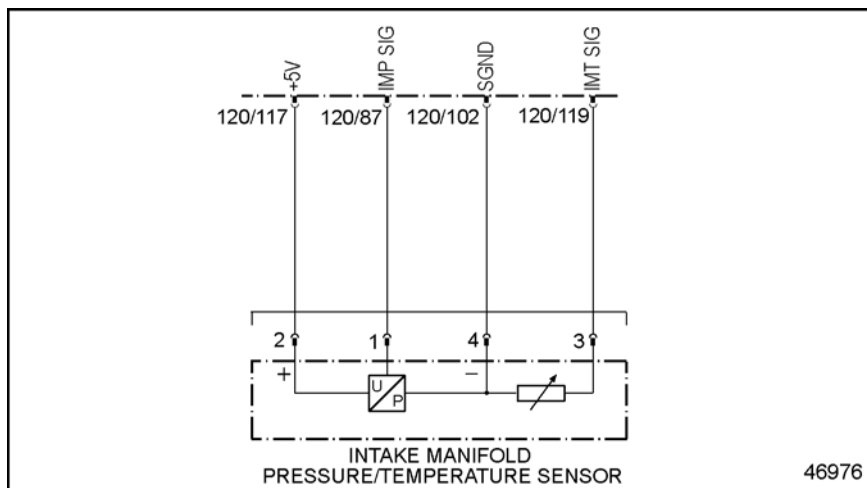
Figure 1 Intake Manifold Pressure/Temperature Sensor

This diagnosis is typically Intake Manifold Pressure Sensor circuit failed low.

1. Disconnect the Intake Manifold Pressure/Temperature Sensor.
2. Disconnect the MCM 120-pin connector.
3. Measure the resistance between pin 1 of the Intake Manifold Pressure/Temperature Sensor and ground.
 - [a] If the resistance is less than 3Ω , repair short to ground between pin 87 of the MCM 120-pin connector and pin 1 of the Intake Manifold Pressure/Temperature Sensor.
 - [b] If the resistance is greater than 3Ω , replace the Intake Manifold Pressure/Temperature Sensor.
