No.: 07 TS-57  
November 7, 2007

SUBJECT: **EPA07 MBE 900 SRA2 Actuator Adjustment**

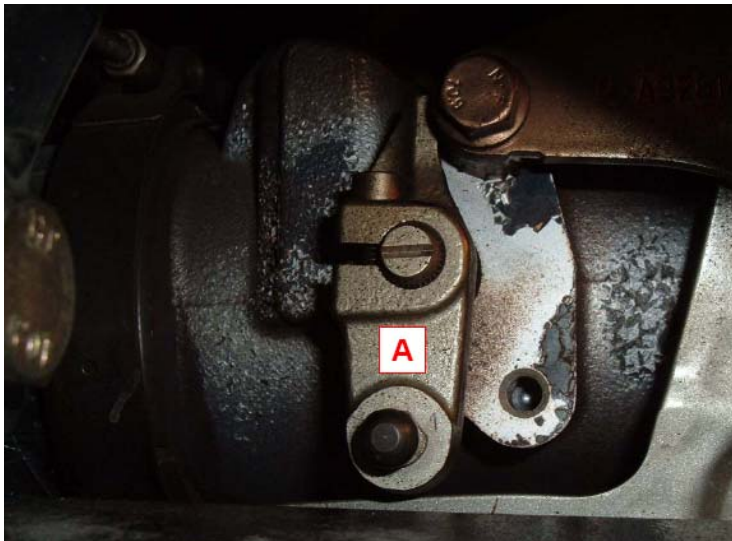
Figure 1 – Exhaust Flap Lever

The Electronic Engine Brake Actuator (SRA2) causes concerns of Low Power with fault code 615/14. These conditions can be corrected by adjusting the SRA2 actuator linkage.

1. Turn ignition switch off.
2. Remove linkage from actuator lever.
3. The exhaust flap must be in the fully opened position, with the lever in a downward position (see Figure 1).
