No.: 07 TS-60
November 19, 2007

SUBJECT: **EPA07 MBE 4000 Code SPN 615/FMI 14 - Turbocharger Boost System Performance**

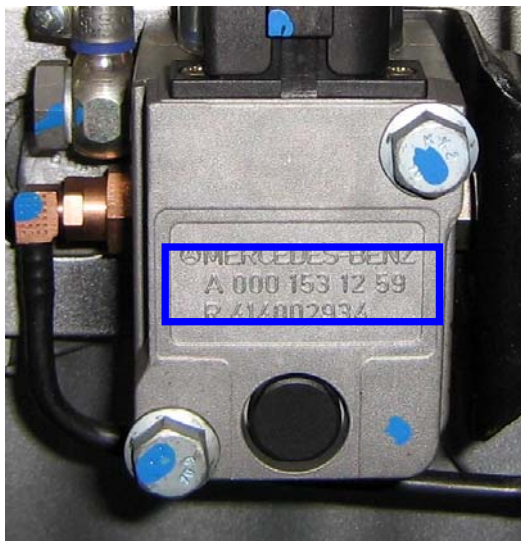
Figure 1 – VPOD Part Number Location

Detroit Diesel has identified a high incidence of Low Boost complaints with fault code 615/14 (Turbo boost performance) on the MBE 4000 engine due to the installation of an incorrect VPOD.

Verify the correct VPOD part number. Correct P/N for EPA07 is A0001531259. Please check for the correct part number (see Figure 1). Valves labeled A0001530959 are NOT acceptable for use on 2007 models.
