**No.: 09 TS-9**  
February 27, 2009

SUBJECT: **MBE 4000 Block-to-Cylinder Head Joint Repair Information**

# MBE 4000 Head to Block Joint Repair Information

**Leak Diagnosis, Cylinder Head and Block Repair**

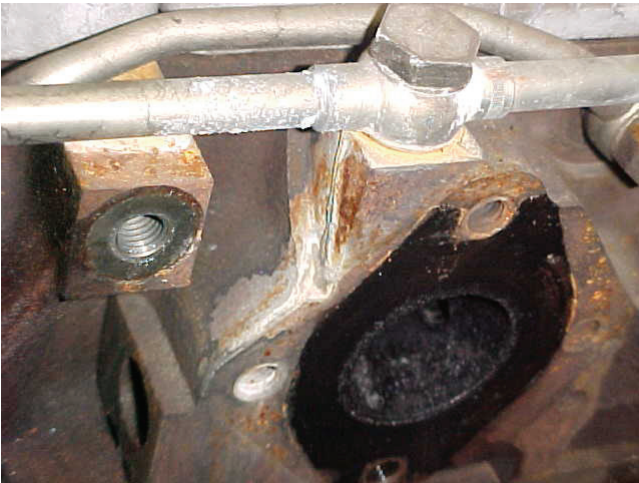
The coolant vent line is often misdiagnosed as a head gasket leak. The coolant vent line is attached to the center top of each cylinder head and is very difficult to see behind the EGR cooler and EGR cooler bracket. However, any leakage from this coolant vent line will show near the head to block joint and down the side of the block. See Figure 1.

**Figure 1.** Typically any leaks from a properly maintained coolant system will show up as the coolant color or white ash if dry.

A product that has been very successful in assisting to find the origin of a coolant leak is tracer dye. Tracerline® offers Dye-Lite® TP-3900 Fluorescent Leak Detection Dye for Coolant Systems. Kits are available with dye and a black light. Information and local source of this product can be found at ([www.tracerline.com](http://www.tracerline.com)). Follow the manufacturer's instructions when using this product (1 oz to 6 gal of coolant, bring the engine to operating temperature,

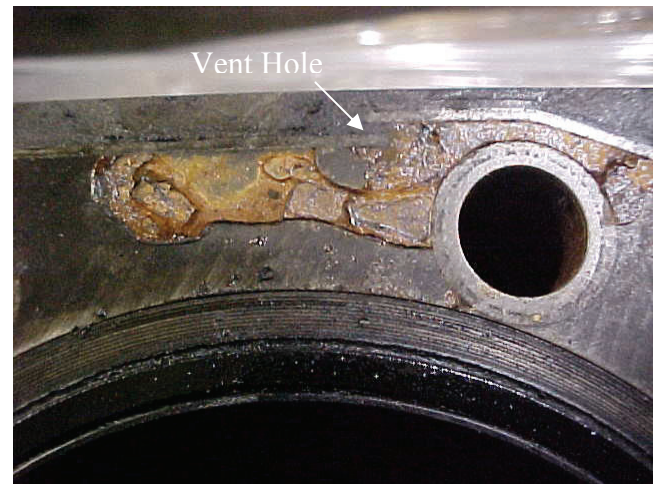
Another area that is misdiagnosed for a leaking head gasket is water (not coolant) seeping from the head gasket vent hole. Any water over the top of the engine drains along the block edge towards the back of the block. As the water passes by the vent hole, a capillary action sucks the water in and drains the water out with the change in engine temperature. This is evident by the rust found near the vent hole side during teardown inspections. See Figure 2.

**Figure 2.** Head gasket vent hole witness marks.

Engines built after Serial Number 0460896913 have head gaskets without a vent hole to address this concern.

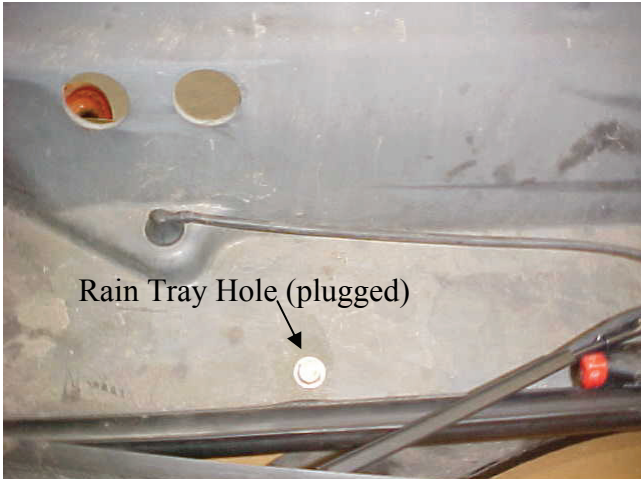
**Note:** Water draining from the truck's windshield rain tray may also contribute to this situation. Rain tray leaks will generally leave a rusty streak since it's plain water. Head gasket leaks are less rusty in appearance and will generally appear just wet. Rain tray leaks are usually location specific on the engine. Columbia/Century/etc will have rusty streaks between cylinders 5/6 because the rain tray hole is directly above that joint between the cylinders. In Sterling car haulers, the rusty streaks will be up around either cylinders 1/2 or 2/3 because the engine is set farther under the cab in that application. Reference Freightliner bulletin 60-140 and Sterling bulletin 60-21 for more info on plugging the rain tray hole. See Figure 3.

**Figure 3. Plugging the rain tray drain hole may reduce water draining on top of engine.**

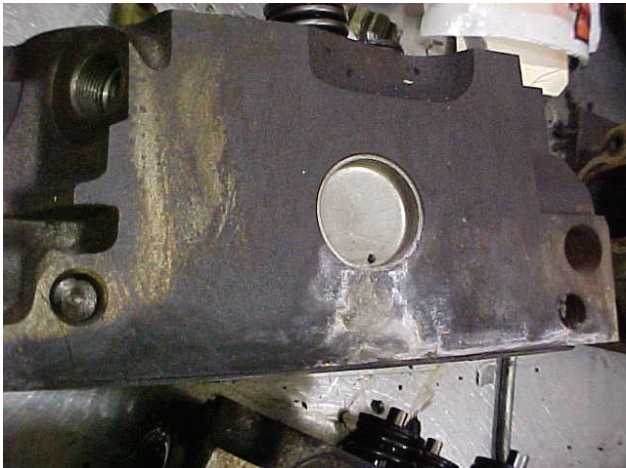
Cylinder head cracks and cup plug leaks will also show up as coolant leak witness marks on the sides of the engine block. Follow the service manual procedure for pressure checking cylinder heads to validate the heads if suspect leaking is found. See Figure 4.

**Figure 4. Leaking cylinder head cup plug.**

Typically the rear of the cylinder head and the rear cup plug have been more prone to cracks and leaks due to being on the exhaust side and exposed to higher temperatures.

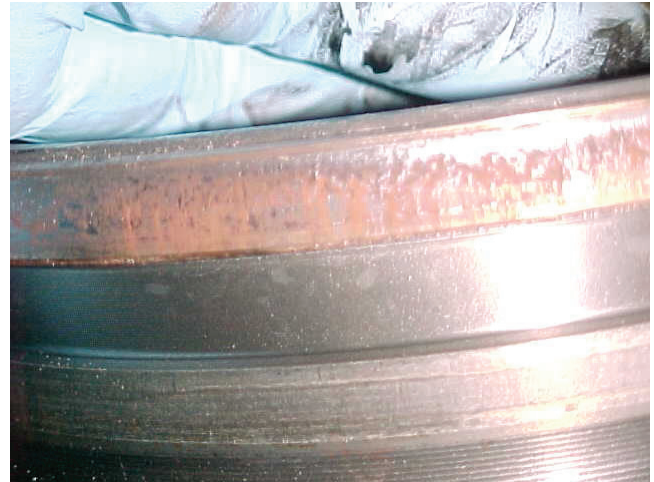
Units with considerable miles or severe duty cycles may have liners that have loosened in the bore. This condition may be evident by erosion and fretting

**Figure 5. Fretting around cylinder liner from high mileage.**

around and under the liner flange. With the release of a new liner, o-ring seal, and counterbore cutting tool, this concern is completely repairable; reference 08 TS-8Rev for complete details on performing this repair. See Figure 5.

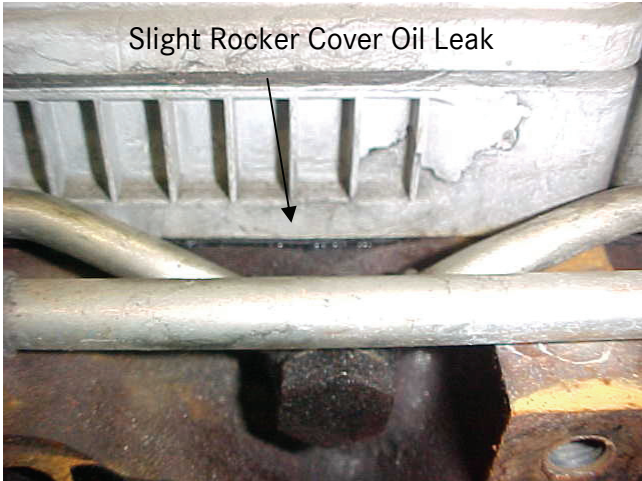
Rocker cover gasket leaks are the predominate source of oil leaks. See Figure 6. This leak will typically be heavy staining of the sides of the block and allow dirt to stick. Normal inspection is made difficult by most of the sealing surfaces being hidden behind other components. Rocker cover gaskets are reusable, therefore tightening of the rocker cover hold down bolts may be the only service required.

**Figure 6. Rocker cover oil leak.**

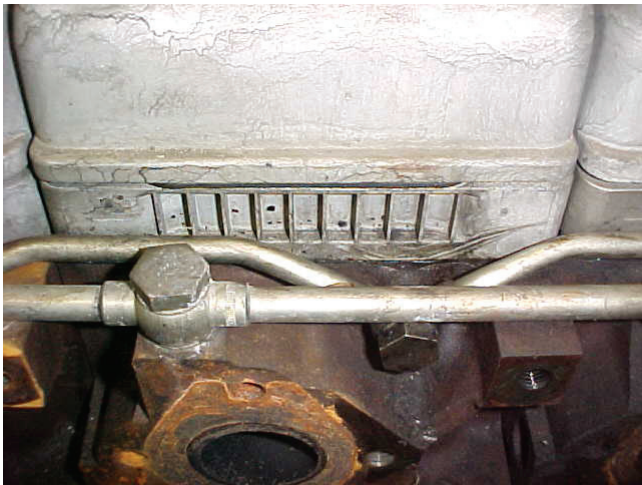
The Constant Throttle Valve line is another possible source of oil leaks to consider. The CTV line is hidden behind the EGR cooler and EGR cooler brackets, there is a connection on the exhaust face of each head and will leave oil traces down the side of the block. See Figure 7.

**Figure 7. Oil traces from leaking CTV line.**

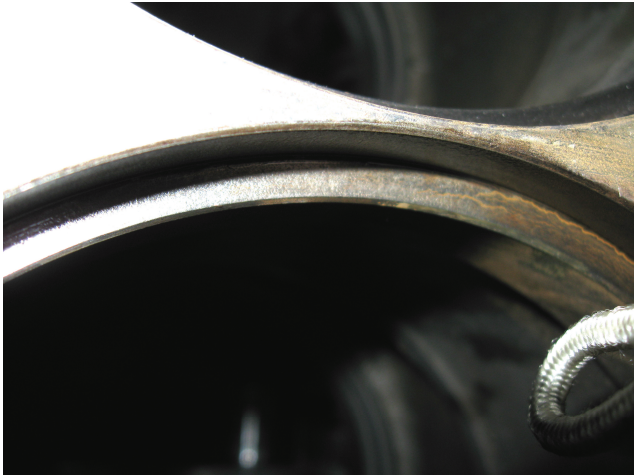
Counterbore cracking is primarily caused from thermal and stress relief of the cylinder block; however, these circumferential cracks have no influence on the sealing area and are acceptable for engine overhaul. See Figure 8. Any erosion of the counterbore can usually be cleaned up with a light cutting. Liner heights are the most important dimension to be maintained for proper sealing. Shim

**Figure 8. Cracking around counterbore circumference.**

thickness must match the cut depth to ensure the appropriate liner height.

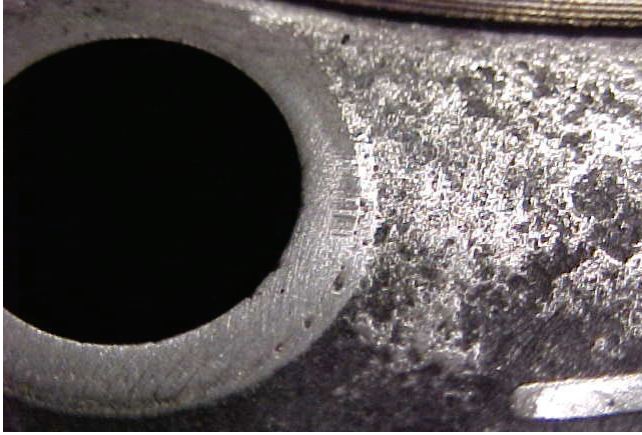
Pitted surfaces that are not in a sealing or grommet area should not be a problem, but they do look bad and if in question or they are in a sealing area there are epoxy products recommended to repair these areas. See Figure 21.

**Figure 21. Repairable block surface using Devcon Titanium Putty 10760.**

Devcon® Titanium Putty 10760 with cleaner is a recommended epoxy for filling in pitting. Also Belzona® 11311 Ceramic R-Metal is considered an industry standard. Follow the manufacturer's instruction when using these products. It is always better to use these products sparingly to minimize the removal of excess material. These epoxies can also be used to fill-in pitting found on the seat of the counterbore. The sides of the counterbore have minimal effect and should not be a concern if pitting is found there. See Figure 22. Contact information for the epoxy can be found at [www.devcon.com](http://www.devcon.com) and [www.belzona.com](http://www.belzona.com).

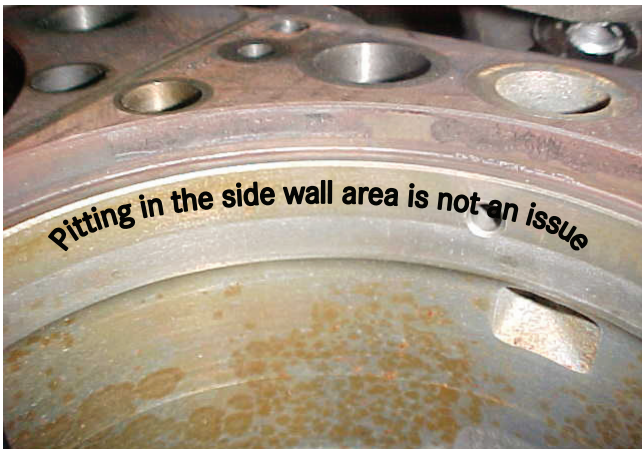
**Figure 22. Sidewall pitting is not critical.**
