Burned current measuring resistors on AID2-01

<input type="checkbox"/> Campaign	<input type="checkbox"/> Modification	<input checked="" type="checkbox"/> Service Information letter
Valid from: 2015-05-05	<input type="checkbox"/> Action required	<input checked="" type="checkbox"/> For information only
<input checked="" type="checkbox"/> Worldwide or	<input type="checkbox"/> North America	<input type="checkbox"/> China
	<input type="checkbox"/> Latin America	<input type="checkbox"/> Northeast Asia
	<input type="checkbox"/> Eastern Europe / CIS	<input type="checkbox"/> Southeast Asia
	<input type="checkbox"/> Mediterranean	<input type="checkbox"/> Australia / Pacific
	<input type="checkbox"/> Northern / Central Europe	
	<input type="checkbox"/> Turkey, Middle East, Africa	
<input type="checkbox"/> Sales	<input type="checkbox"/> Spare Parts	<input type="checkbox"/> Service
	<input checked="" type="checkbox"/> Warranty	<input type="checkbox"/> OEM Information

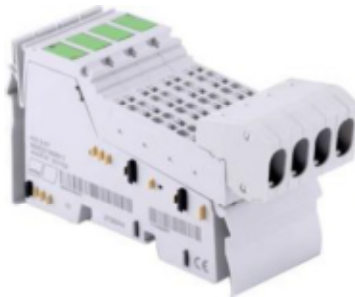
According to information from the manufacturer, the problems are due to excessive input voltages at the current inputs. These excessive input voltages can be caused by defective or incorrectly connected sensors.

The maximum permissible input voltage at the current inputs is $\pm 2.5V$!
Here $\pm 2.5V$ is equivalent to $\pm 100\text{ mA}$.

These measuring resistors can be compared with one another between terminals 1.2 & 1.3 and 2.2 & 2.3. Large differences indicate damaged measuring resistors.

If these components fail, details of the defective channel and the connected sensor must be indicated when they are sent back.

Additionally, the cabling must be checked!

Faults in the cabling and/or during measuring (e.g. current measurement over the current sensor) must likewise be indicated when sending back the units!
