2011 Sales & After Sales
Conference

Mercedes-Benz Product Support

Detroit, MI - January 20, 2011 - Chris to Roxel

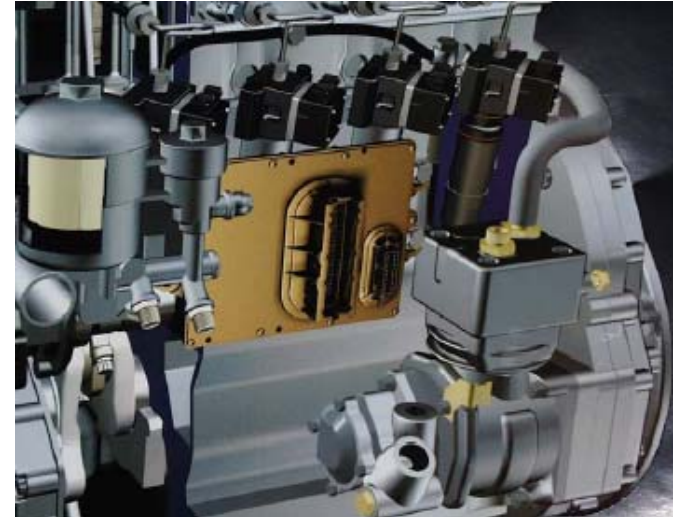
Difference in Off-highway and On-highway Part

Service MR2 not accepting fuel map of engine

An on-highway service MR2 is being used for an off-highway application

Use the current off-highway specific MR2

MTU DD stocks off-highway V06 MR2 (part number 0044467140)

V08 and V10 MR2 part number will be released in the first quarter of 2011

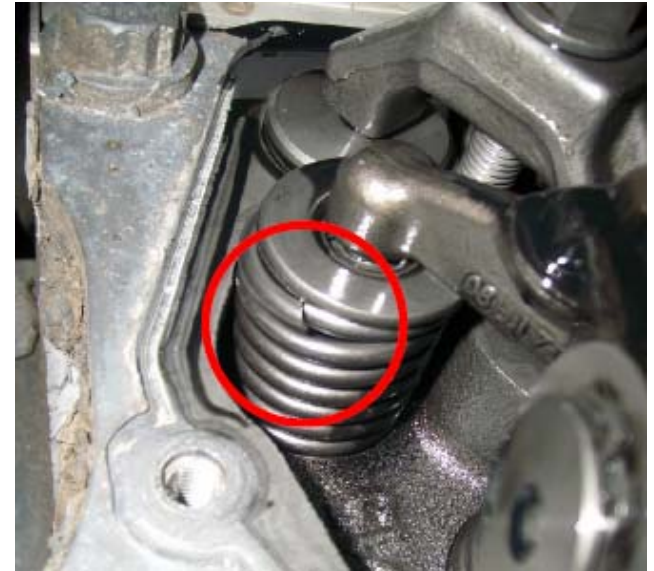
Valve Spring Failures Series 500

Broken valve springs.

Root Cause

Under investigation.

Replace with current service springs.

Only fix failed springs as needed.

Service springs are available at the PDC.

Process to replace springs without pulling the head is available.

Updated spring is in test .
