# LC50 Fuel Mixer and Speed Control

Set-up / Troubleshooting

**OLYMPIAN™**  
**GENERATOR SETS**

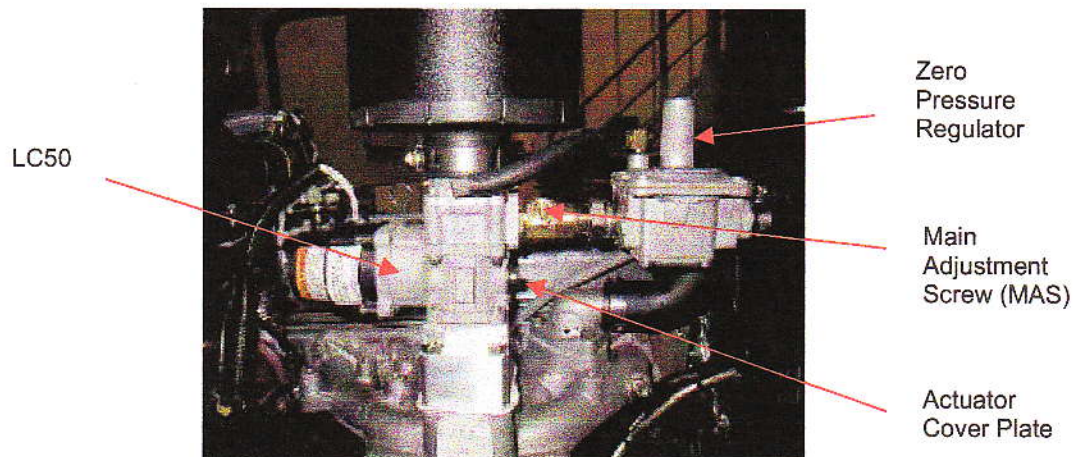
- There are no external speed control linkages.
- The LC50 incorporates a digital speed control which is factory programmed. No on site adjustments of the speed control are required.
- This system utilizes a zero pressure regulator, therefore a lower natural gas inlet pressure is required (4"H<sub>2</sub>O).
- Both Natural Gas and LPG Vapor units utilize the same regulator configuration, with the exception of the Ford 642 models where a larger regulator will be used for Natural Gas units.

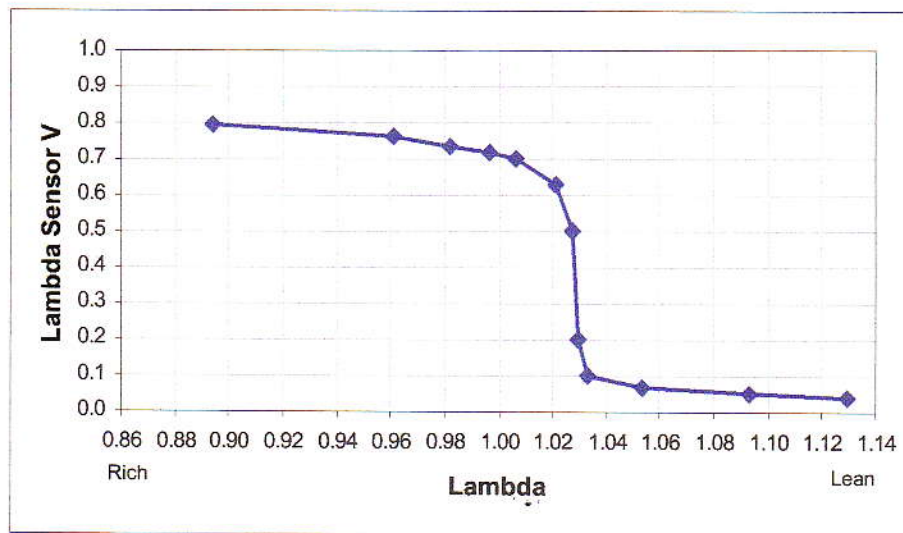
The Lambda sensor gives an output as follows:

1. Start the generator set and check Lambda or CO% at no load.  
If Lambda < 0.96 (Lambda sensor > 0.75V, or CO > 2.5%) the regulator outlet pressure is set too high, adjust the regulator to reduce the outlet pressure.  
If Lambda > 1.04 (Lambda sensor < 0.1V or CO < 0.05%) the regulator outlet pressure is set too low, adjust the regulator to increase the outlet pressure.
2. Increase the load to around 60% of nameplate rating using a load bank, or available building load. Allow the engine time to reach normal operating temperature.
3. Adjust the main adjustment screw (MAS) on the mixer until Lambda = 1.0 (Lambda sensor = 0.7V or CO = 1.0%).
